Manhole Inspection Summary

Manhole # S25I__061MH

Location Address: **S Carlton st (Southwest Vision) behind 1120** Cross Street: **Hollins ST**

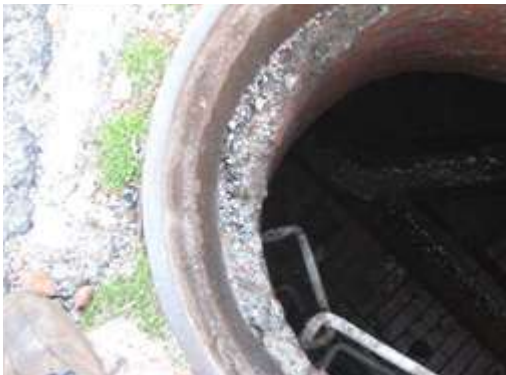
Defect 2

Frame Offset: **2** (in.) Condition: ☐ Sound ☐ Cracked ☒ **Leaks**

offset, frame leaks

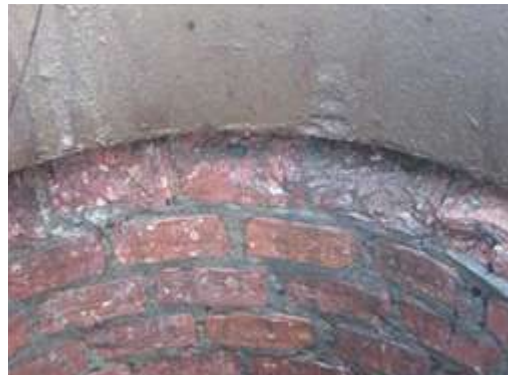
Defect 1

Chimney / Frame Adjustment ☒ Exists Material: **Brick and Concrete** ☐ Parged Height: **6** (in.)
Condition: ☐ Sound ☐ Cracked ☐ Root Intrusion ☒ **Loose Brick** ☐ Deteriorated
Infiltration: ☐ None ☒ **Joint** ☐ Cracks ☐ Mortar ☐ Roots ☒ **Wall**

chimney shows signs of infiltration at 9 o'clock area from joint/wall

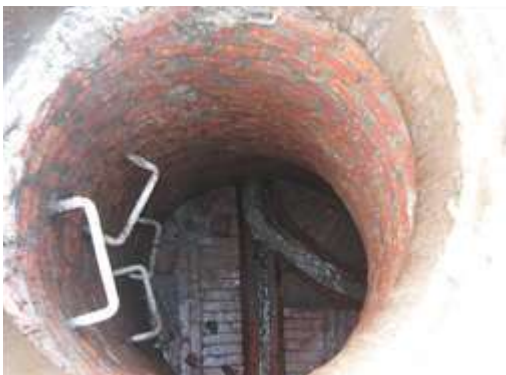
Defect 3

Steps Count: **5** Missing: **0** ☒ **Corroded**

steps corroded, chimney loose bricks
